Presented by
Th. Beumler, Airbus

A contribution of environmental investigations for GLARE[®] riveted joint sizing

TU Delft / Airbus Outdoor Exposure Program

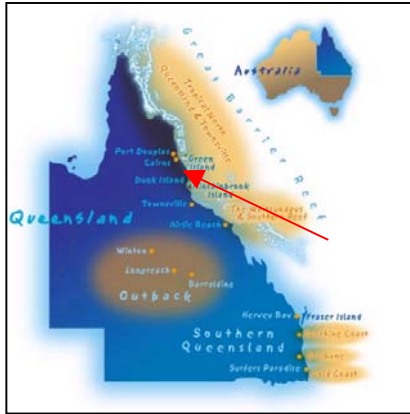
direction of solar radiation

specimen type	GLARE2A / butt strap	GLARE4A / repair	remarks
joints			
blunt notch			
bearing strength			fasteners to be removed after exposure
rivet strength			
compression filled hole			
rivet pull through strength			
moisture reference specimens			GLARE3, riveted specimen shown
riveted repair panels			
bonded repair panels			bondline between skin and patch unprotected
door corner cut out specimens			edges unprotected
tau gamma specimens			fasteners to be removed after exposure

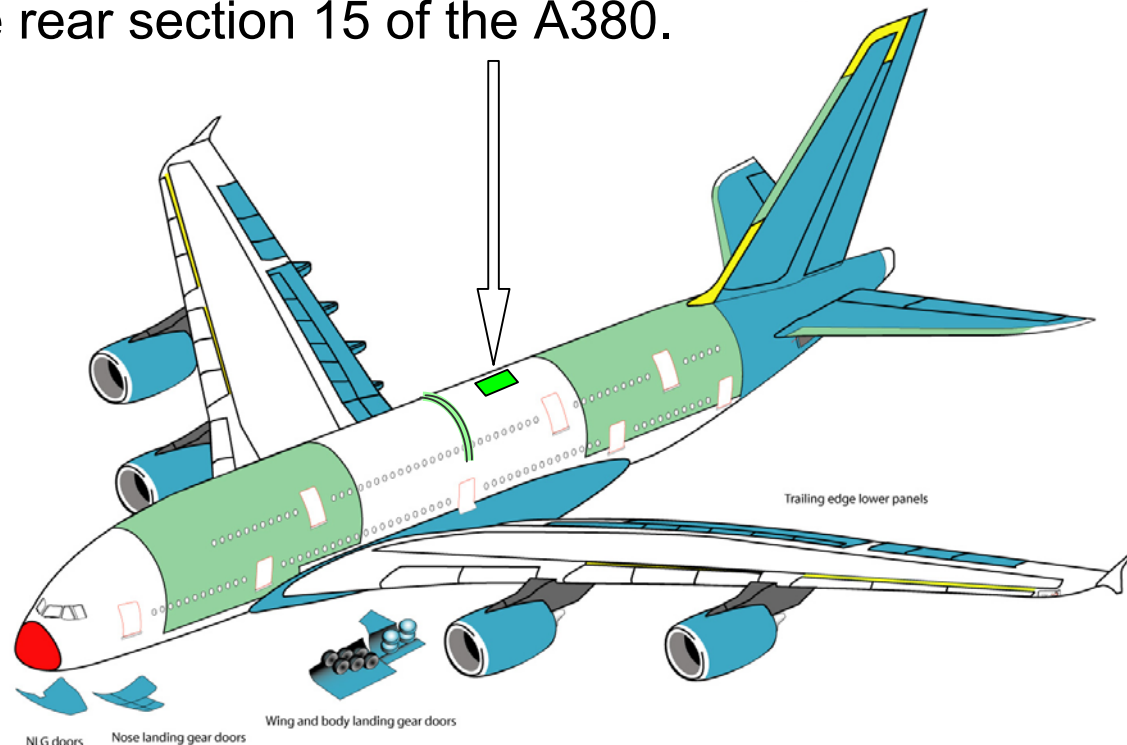
Justification of riveted repair (skin and patch GLARE4A-5/4-.4 ssc, 5.6mm ASNA 2026 bolts) for residual strength.

Loads and design of the repair are representative for an assumed GLARE skin in the rear section 15 of the A380.

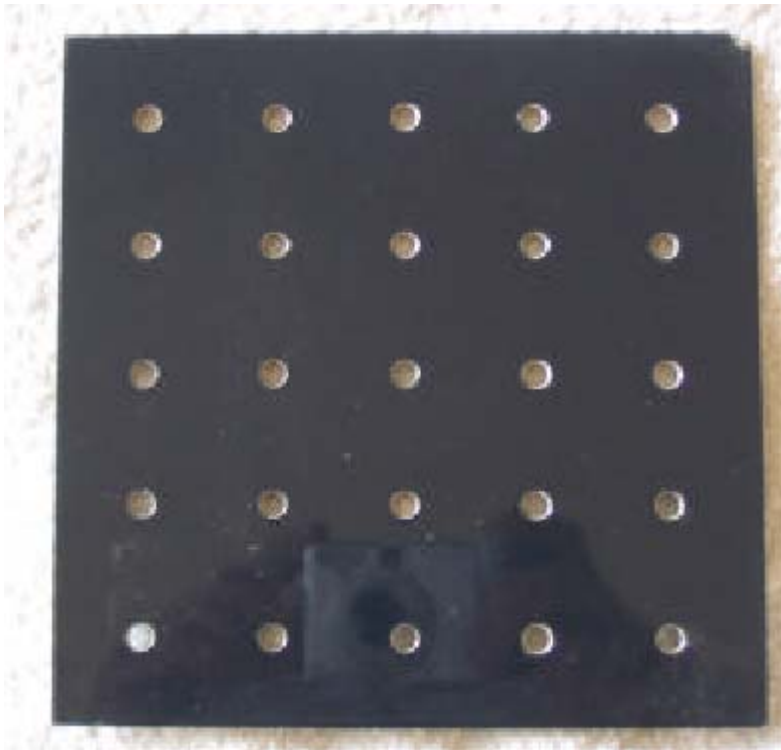
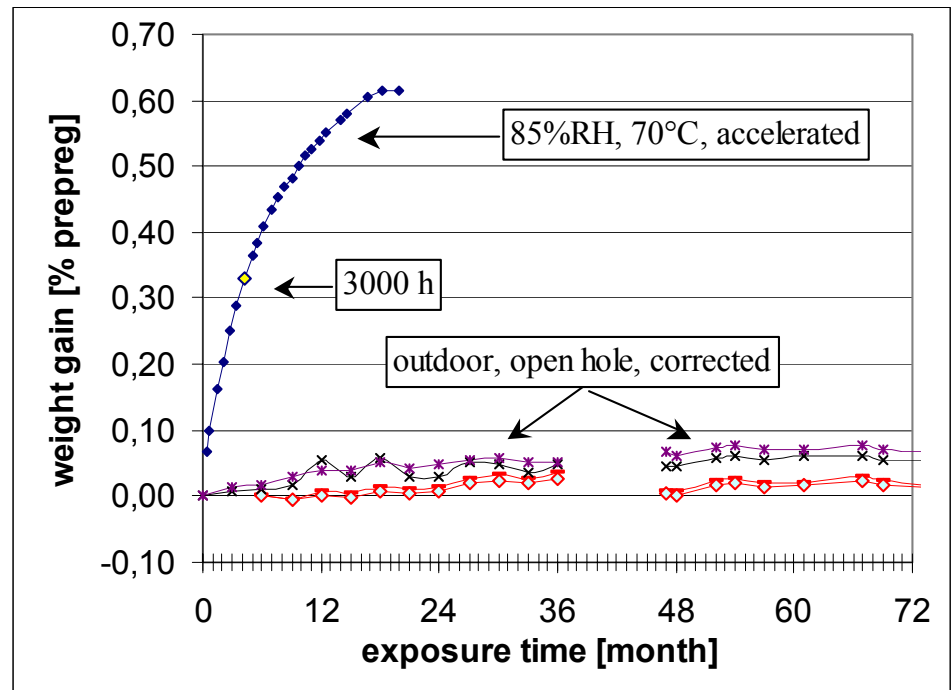
Moisture Reference Specimens

- MRS specimens covered by plexy glass, ASTM G24-97.
- Much less moisture absorbed in Australia than after 3000h ageing in 85%RH/70°C humid air.

- A moisture content and distribution in GLARE around rivet holes similar to that obtained after 6 years exposure in Queensland can be reached as follows:
 - ▶ 9500 hours in an environmental chamber at 30°C / 70% RH
- However, for none of the discussed test series it is necessary to simulate ageing through exposure in an environmental chamber.
- Care has to be taken for the interpretation of test results as soon as corrosion is involved.

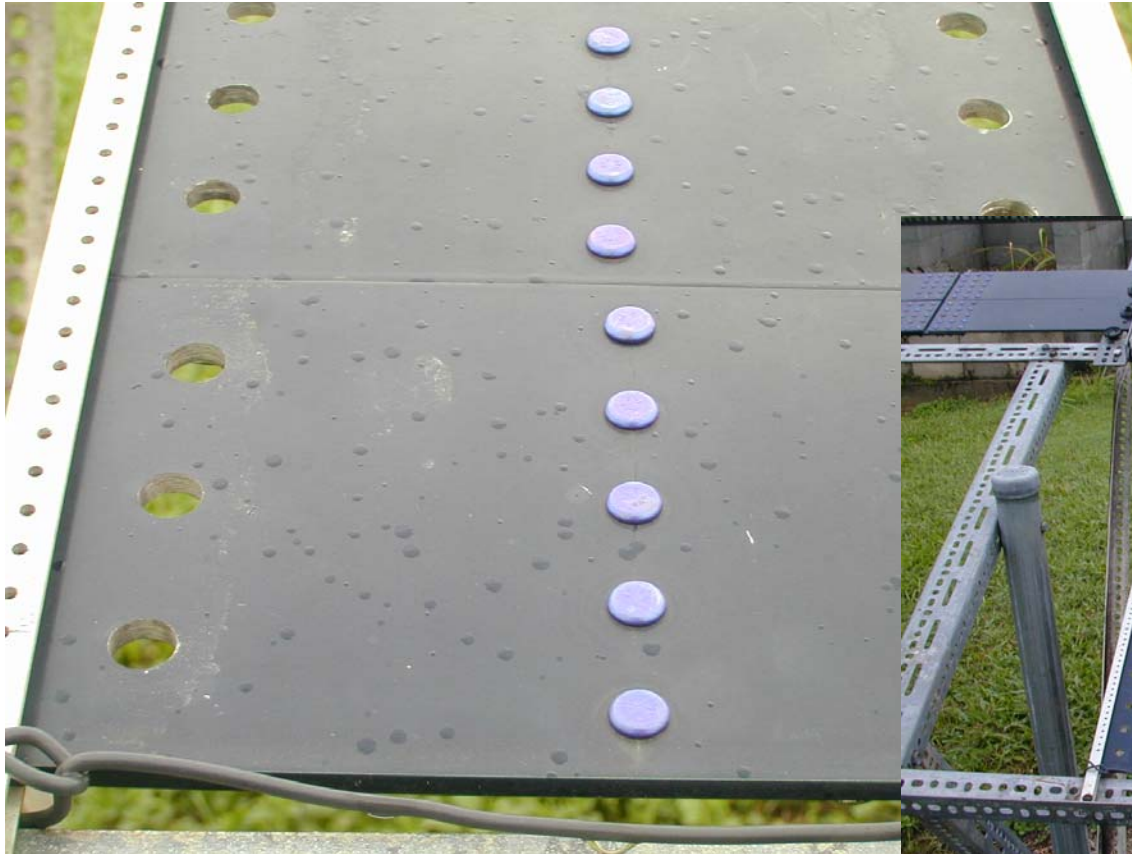
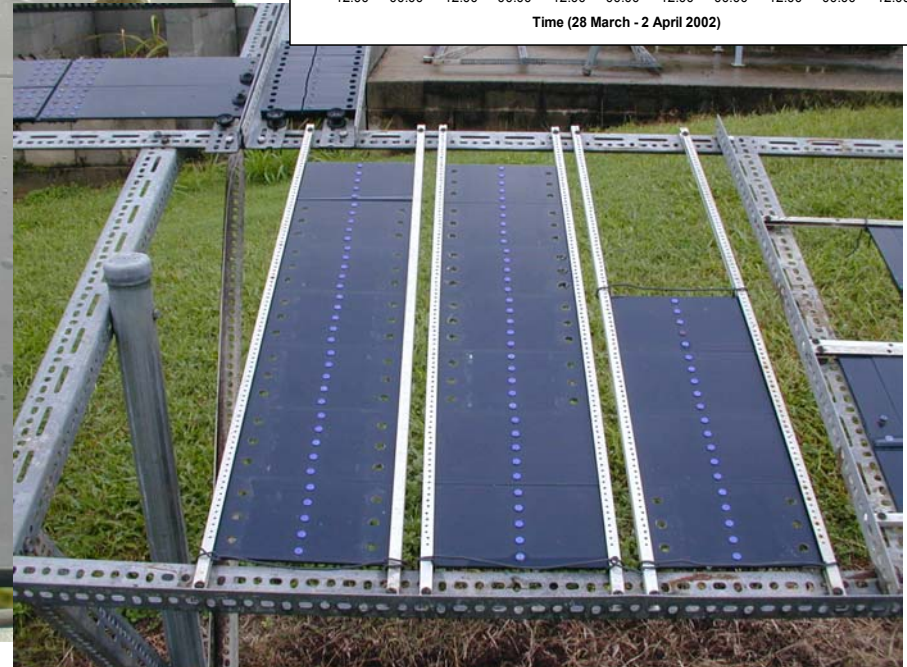
- Mechanic specimens exposed to open sky. Photos from 2003:

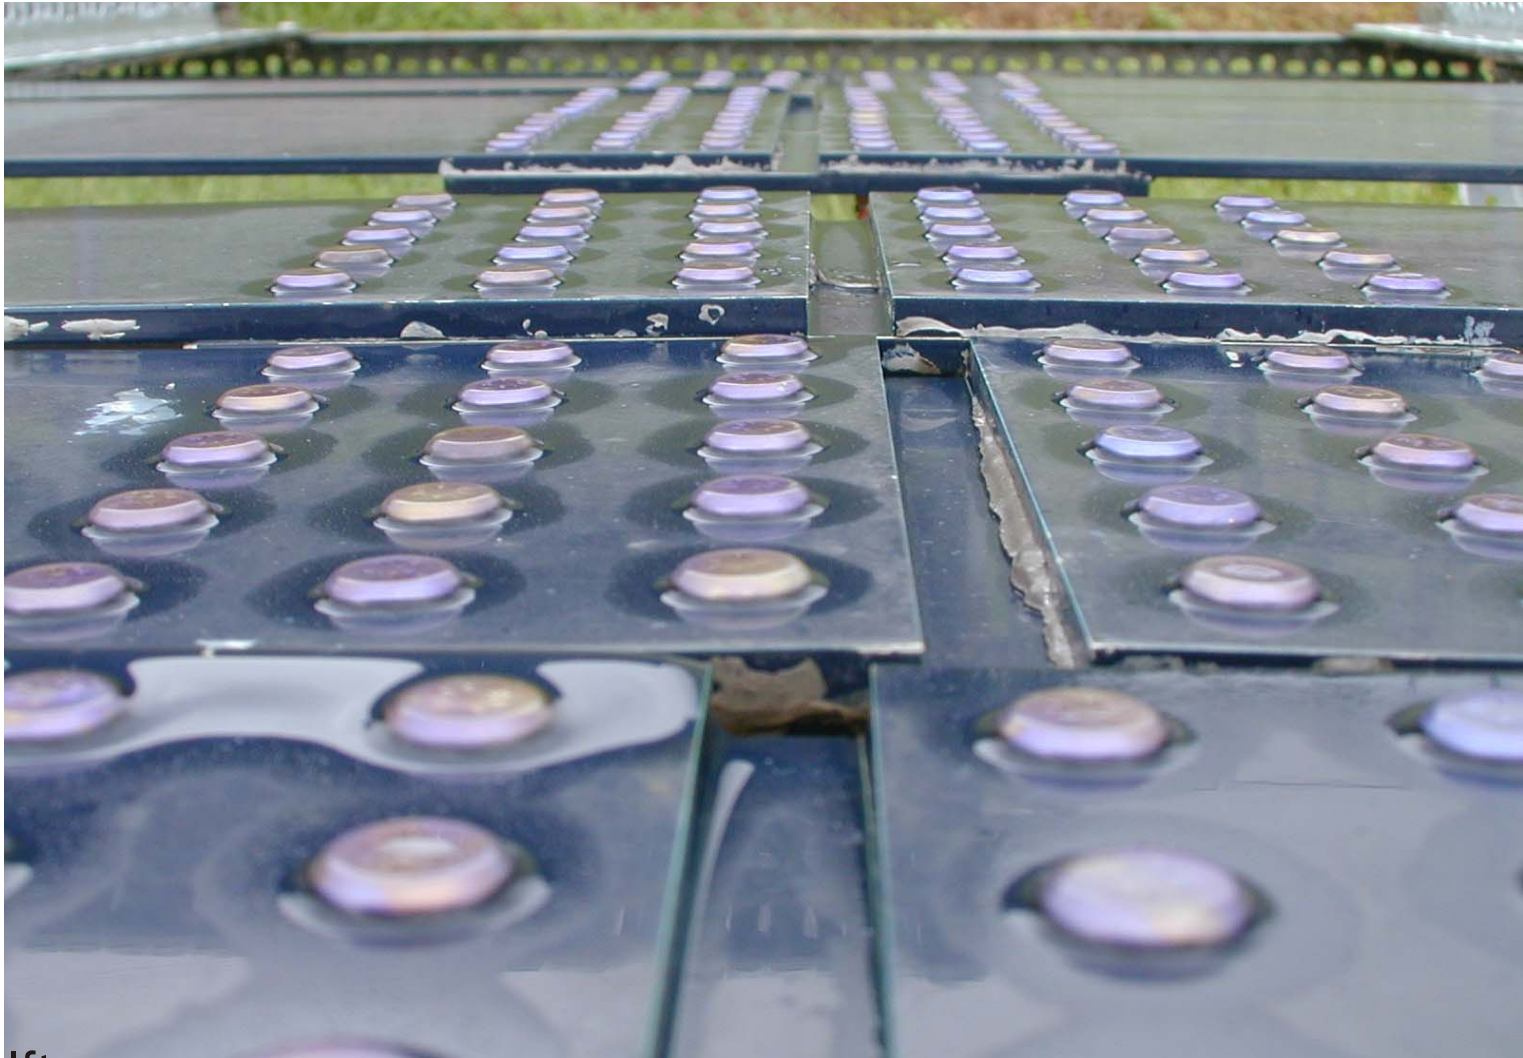
- Riveted joints in 2003

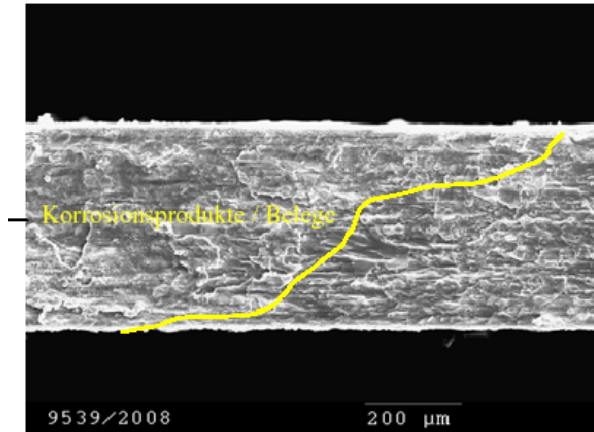
- 1) Painting
- 2) Drilling
- 3) Fastener installation without anti fretting compound (GLARE4A: clearance fit).

→ Access of moisture and rain to fastener holes.

→ Corrosion after 6 years outdoor exposure.

9539/2008 gesputtert
Bild 14: Äußere Aluminium-Lage, rechte Bohrungsseite, Korrosionsprodukte/Belege auf der Bruchfläche im Bereich 1mm von der Bohrung entfernt

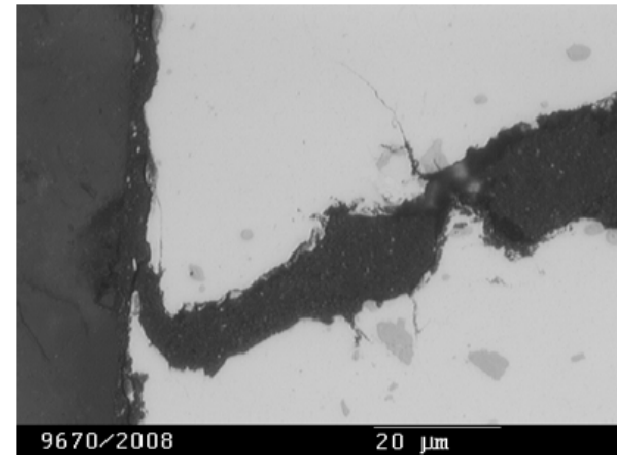
9670/2008 1000:1
Bild 24: Row 3, rivet 1, Korrosionsangriff in der Bohrung und im Riss, Det. aus Bild 23

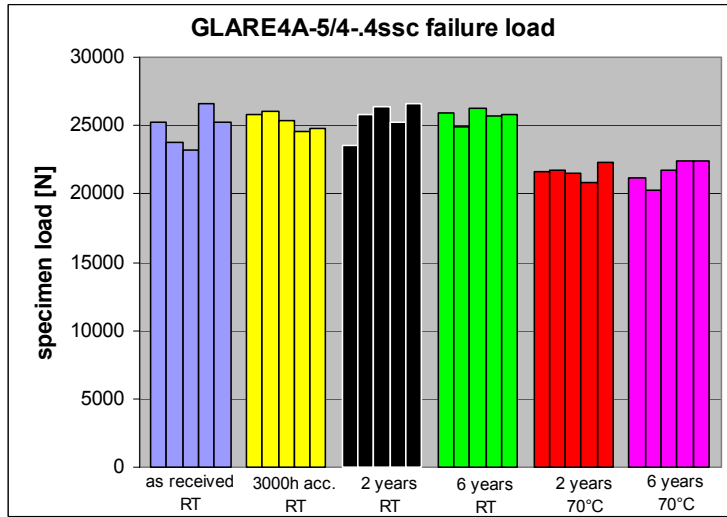
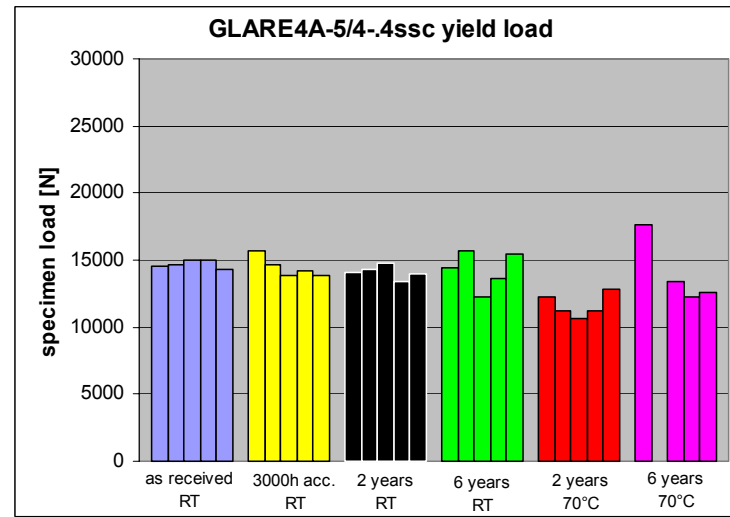
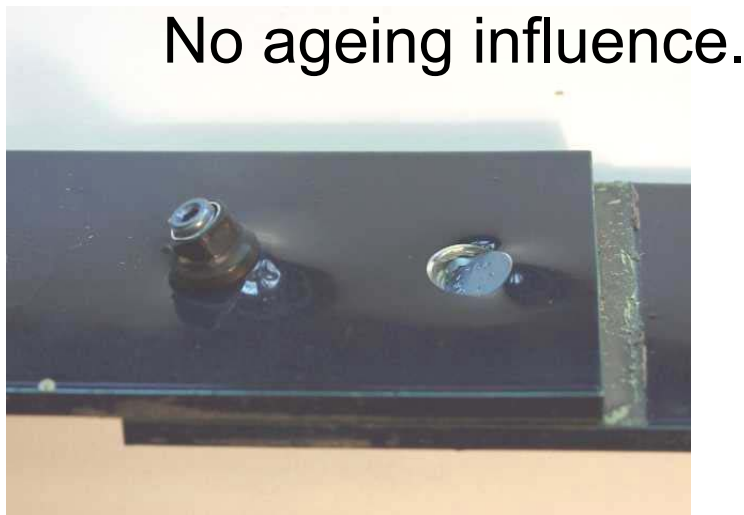
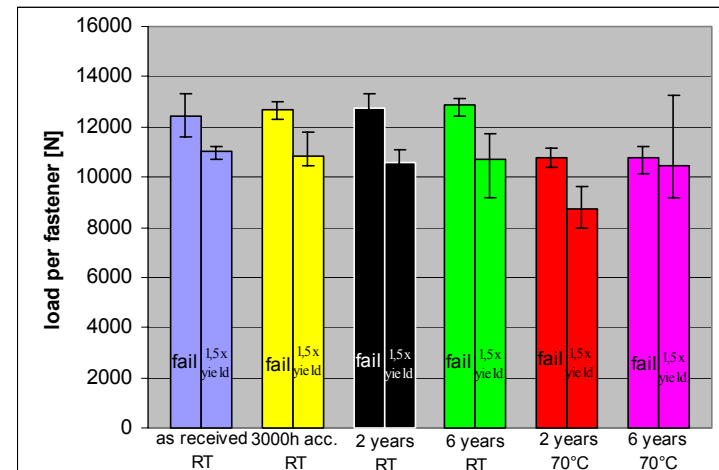
Rivet Strength

- Static tests, i.e. without fatigue cracks; bearing loads.

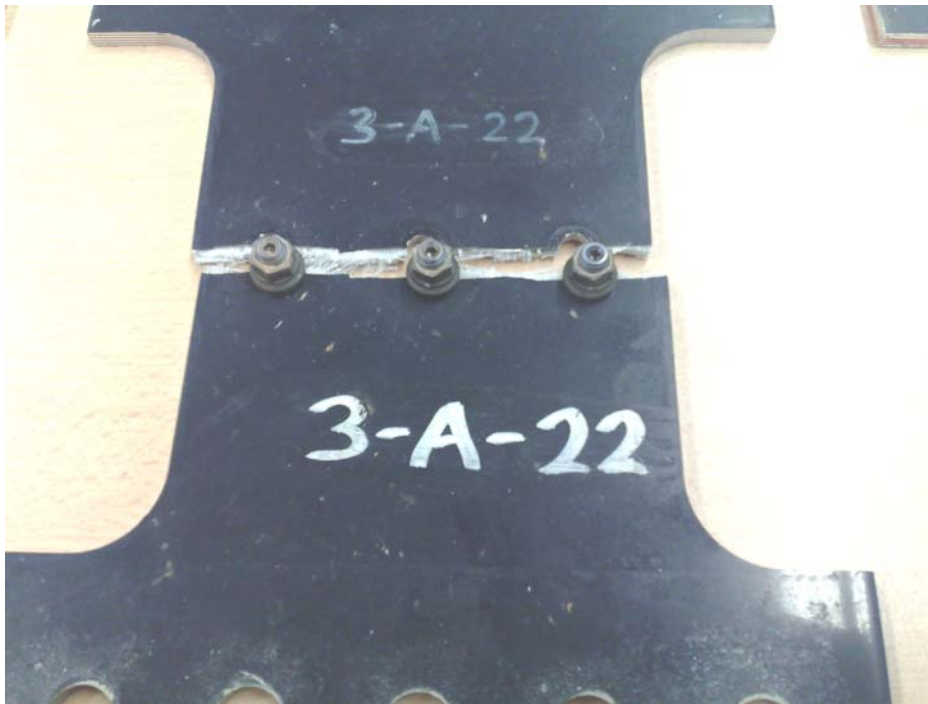
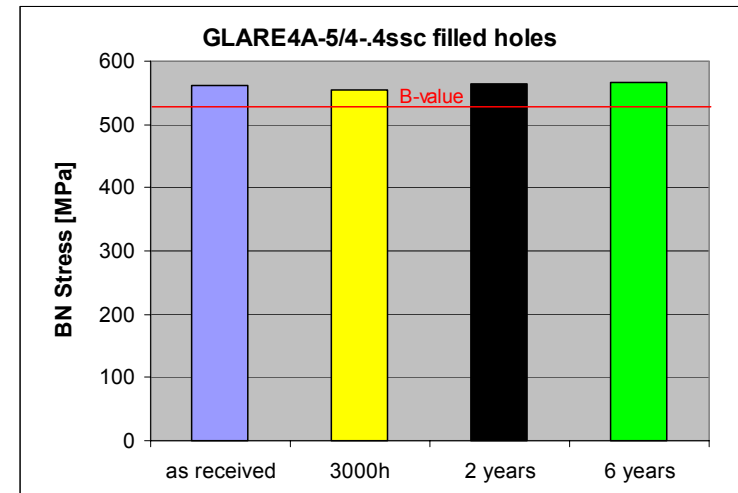
Filled Hole Tension

- BN results, i.e. without fatigue cracks; by-pass loads.

No ageing influence.

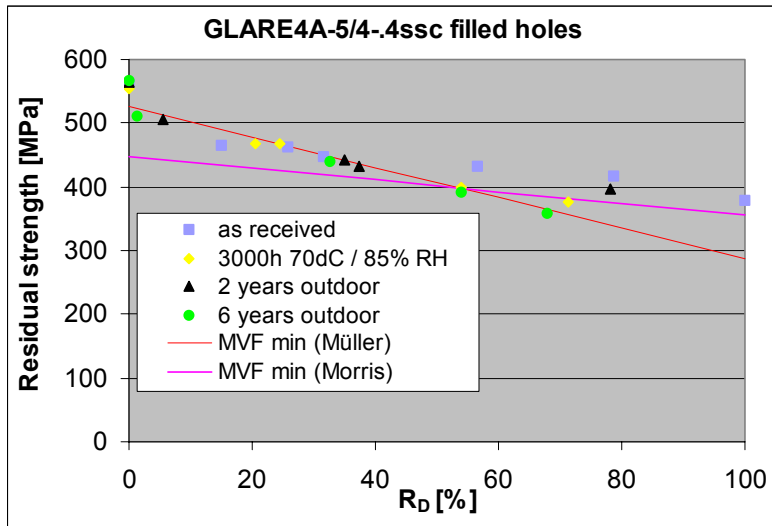
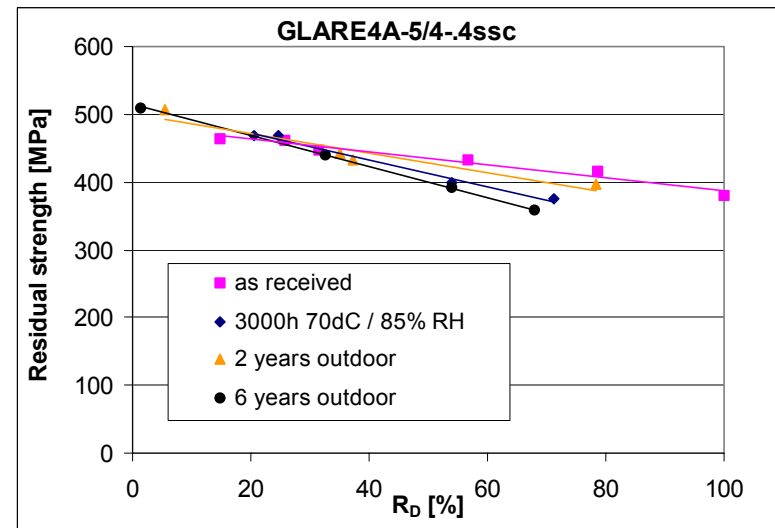
Filled Hole Tension

- Residual strength results, i.e. with fatigue cracks.

- All results close to design curves.

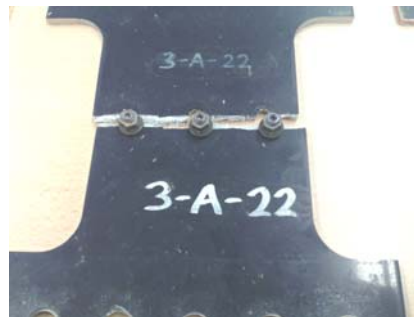
Different slopes ?

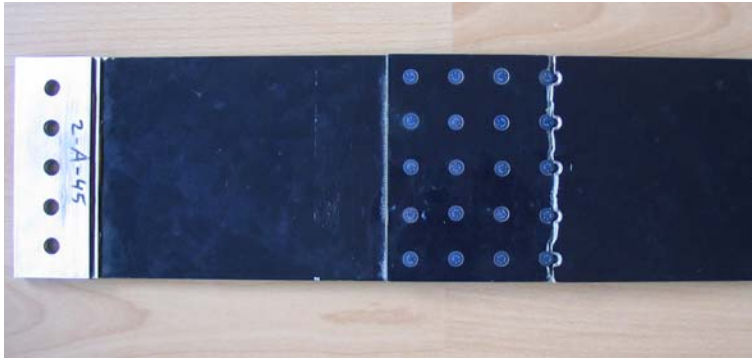
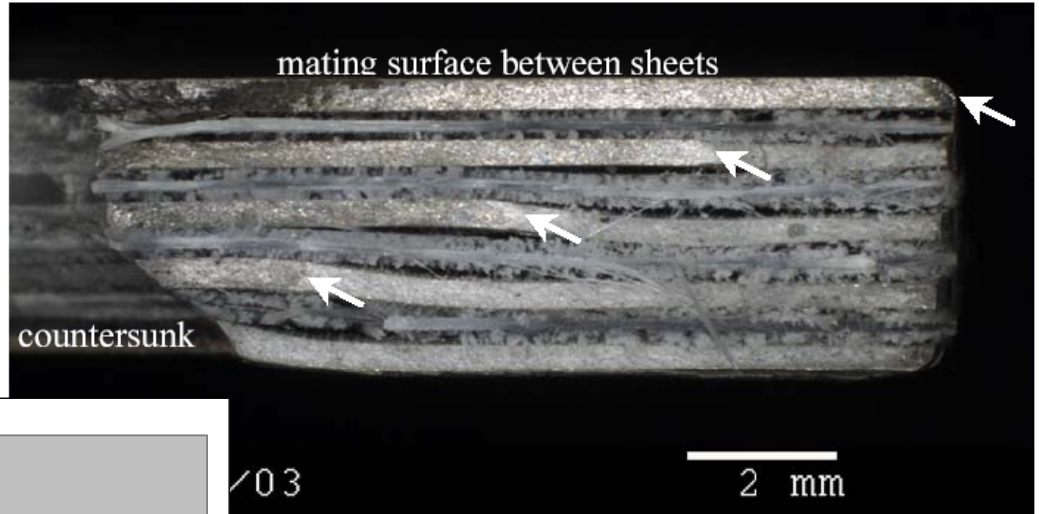
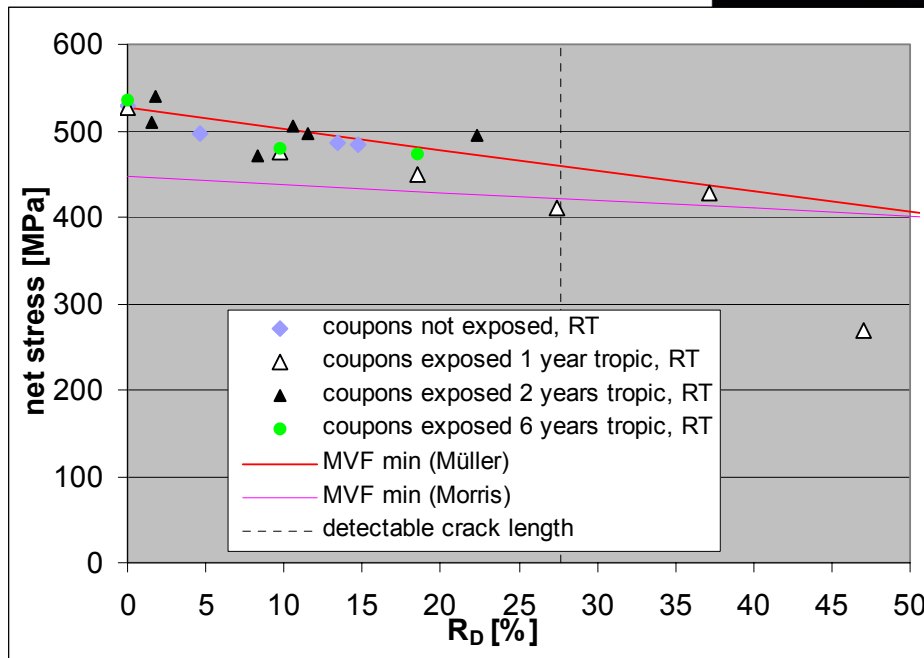
Riveted Joints

- Combined bearing + by-pass stress, secondary bending.

- All results except one close to design curves.

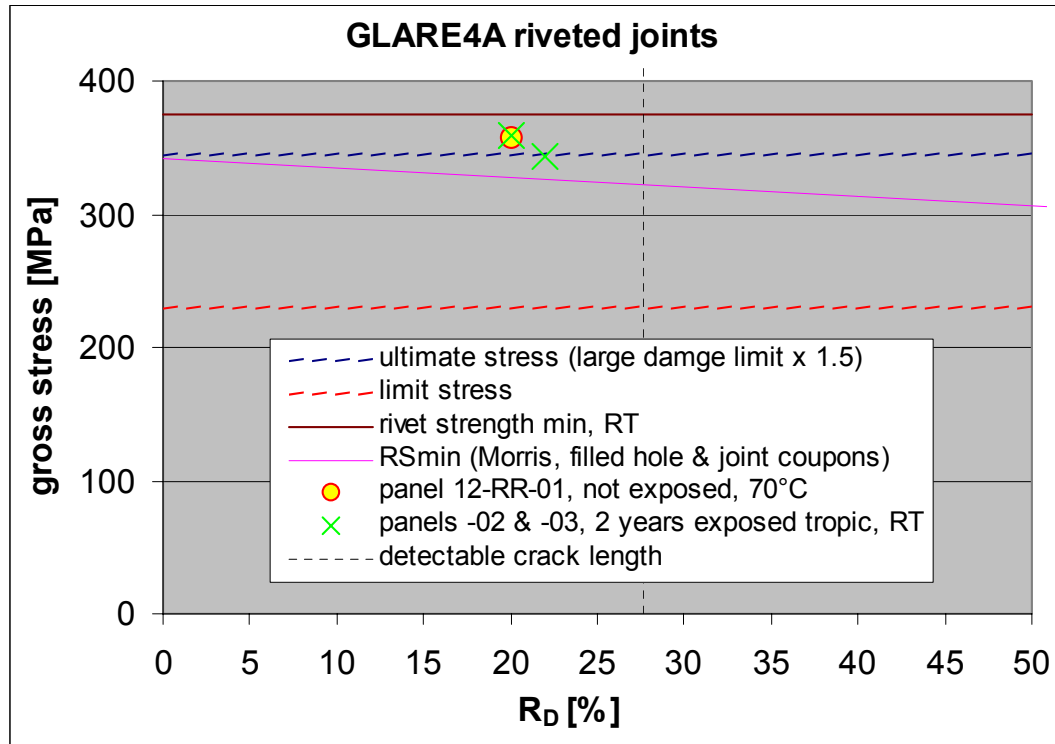
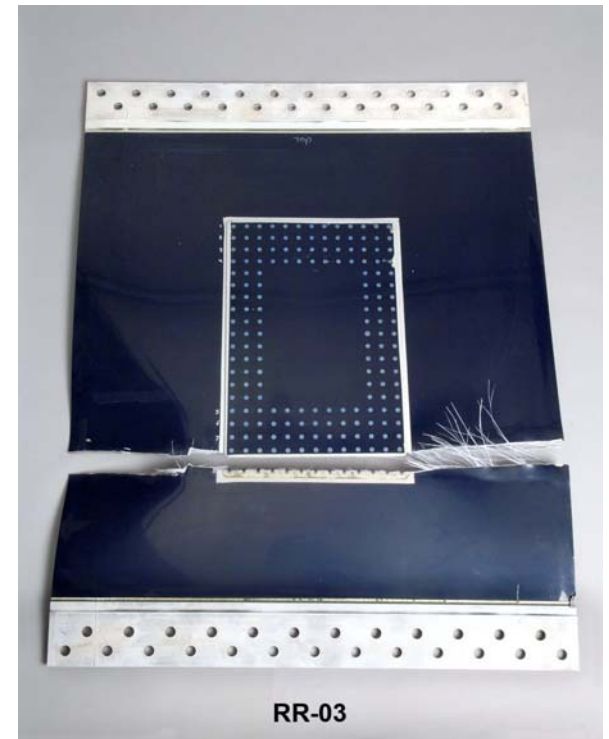
Summary including panel results (gross stress shown).

Considered design criterion for skin: max tensile limit load stress 230 MPa, failure criterion Large Damage Capability and Repairability:

- The loads determining Residual Strength on the rear upper fuselage appear at:
 - ▶ room temperature (landing case)
 - ▶ below room temperature (gust case during cruise)
- therefore the KDF for RS related to Temperature is 1.0
- Outdoor exposure tests show that the KDF for RS related to Environmental Exposure is 1.0 as well, if the Design Curve evaluated by Morris is applied.

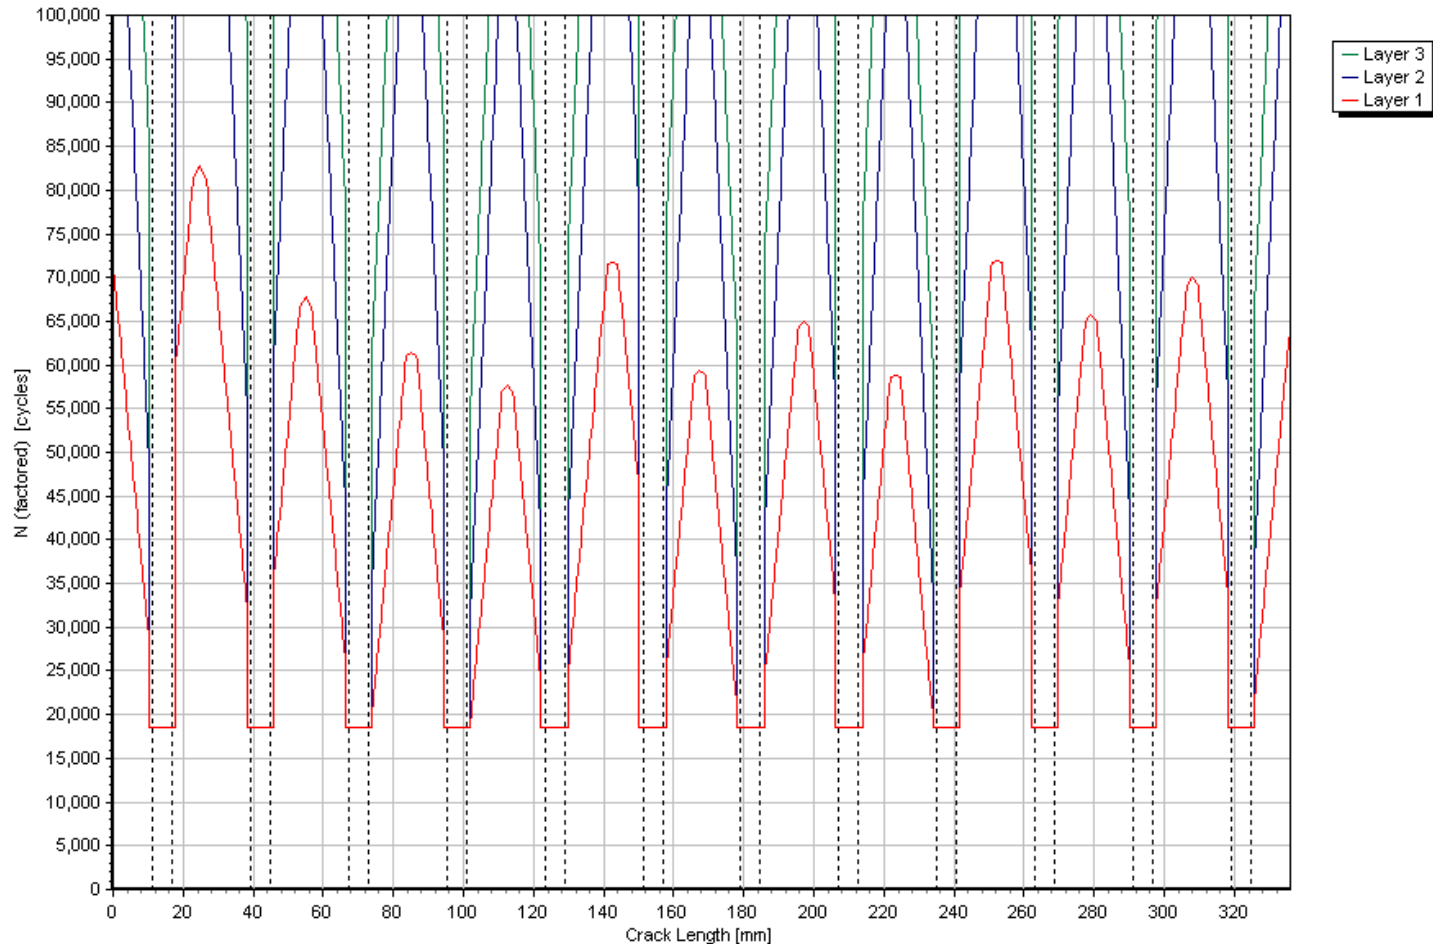
Fatigue strength justification using the TU Delft / Airbus tool „FML F&DT Toolbox“, factorised results:

- One of 150 MSD calculation scenarios, 12 fastener holes in a row:

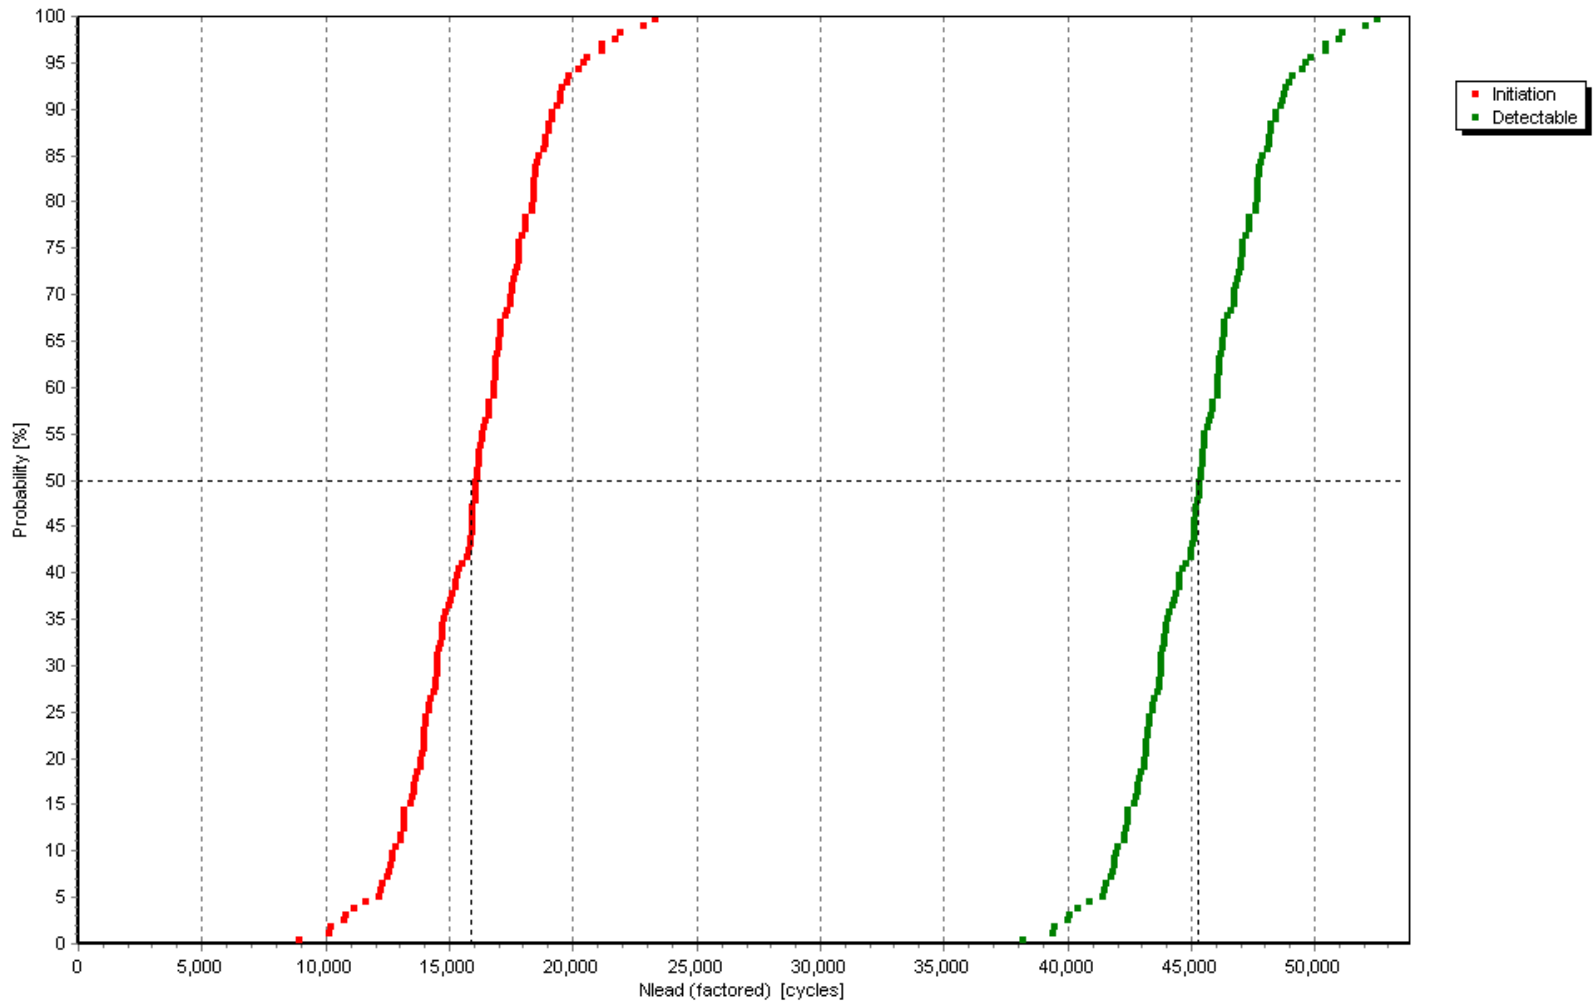
- MSD Distributions for CI and N_{det} (factorised):

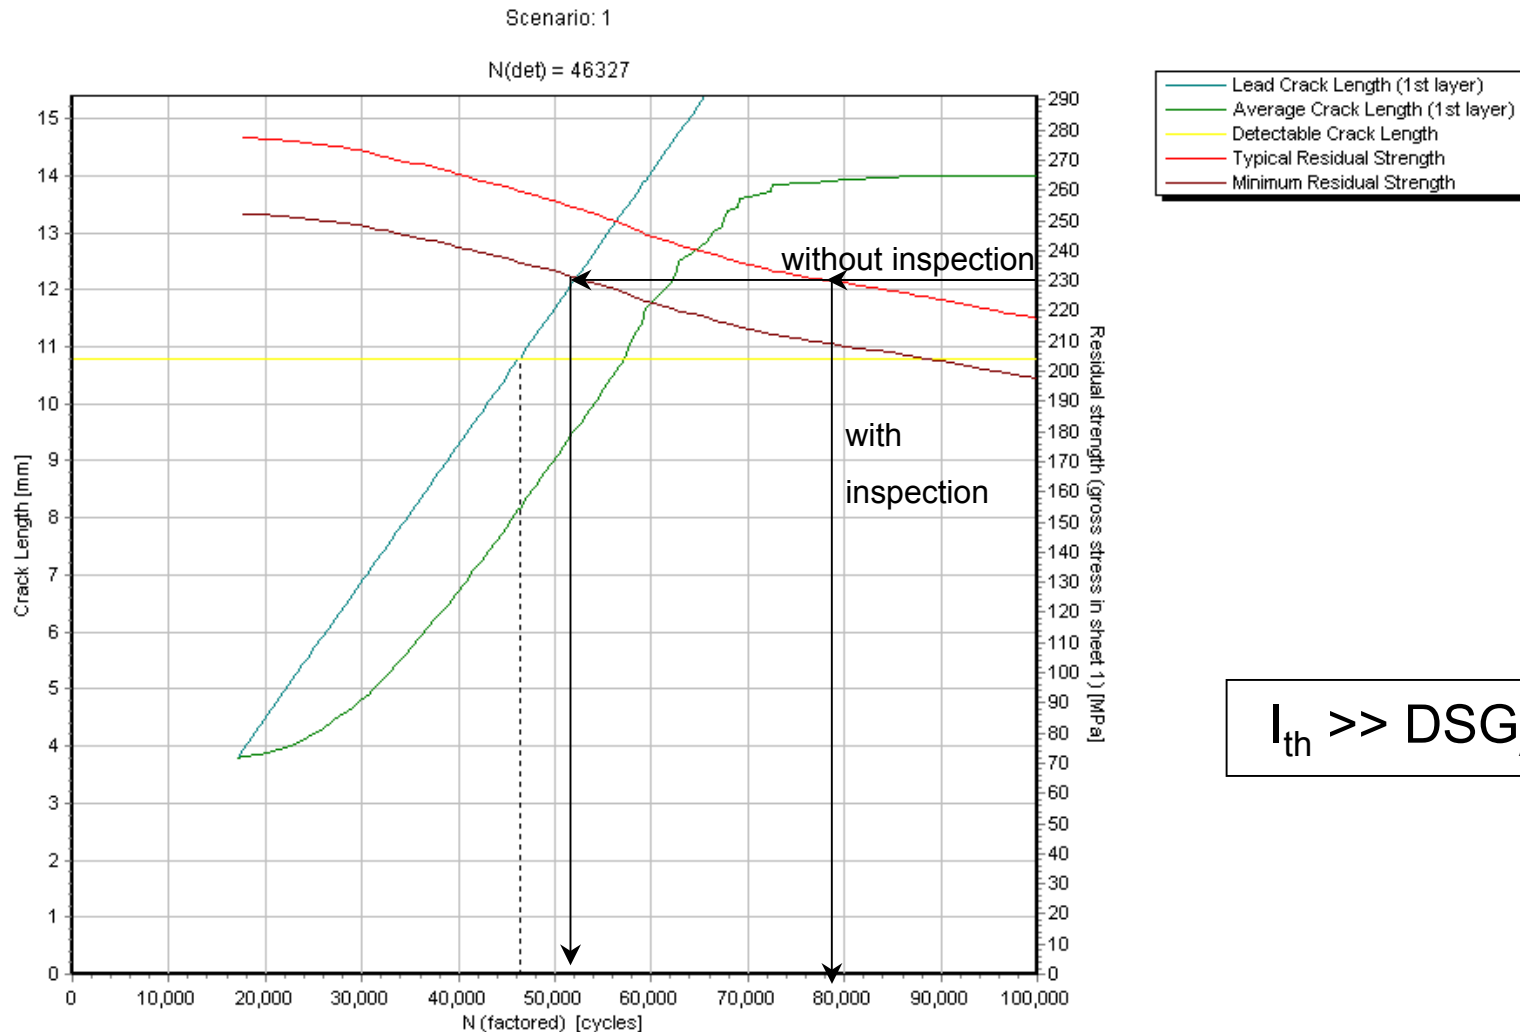
- Justified by full scale test Megaliner Barrel, factorised results:
